# The City of Port St. Lucie's programmatic approach to asbestos cement pipe bursting

**Laney Southerly**, P.E., Project Planning Engineer, City of Port St. Lucie, Florida; **Edward Alan Ambler**, P.E., LEED AP, Vice President, AM Trenchless, Lake Mary, Florida; and **Todd Grafenauer**, Educational Director, Murphy Pipeline Contractors, Milwaukee, Wisconsin

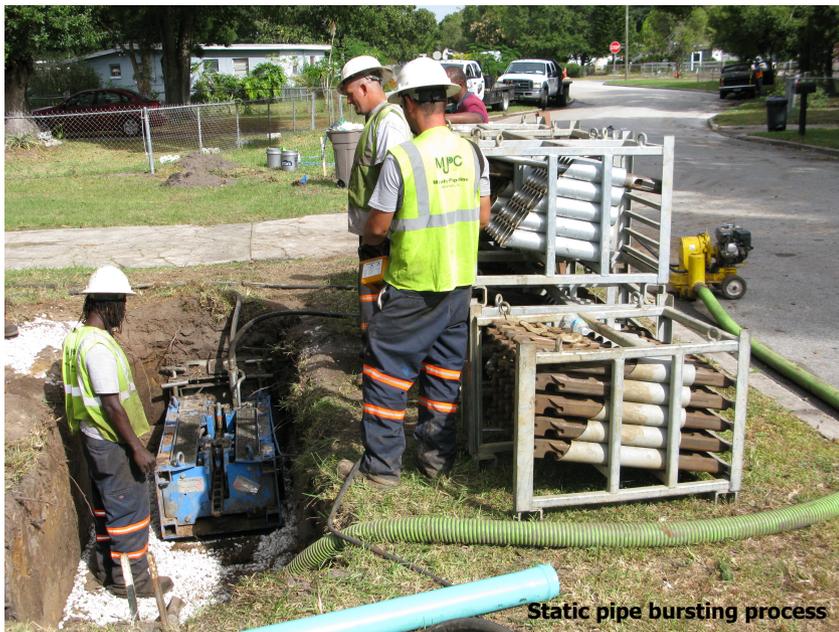
Static pipe bursting process
